NBSIR 74-474

Metallurgical Analysis of Wear Particles and Wearing Surfaces

April 1974

Final Report
NAONR-31-73
NR 229-014

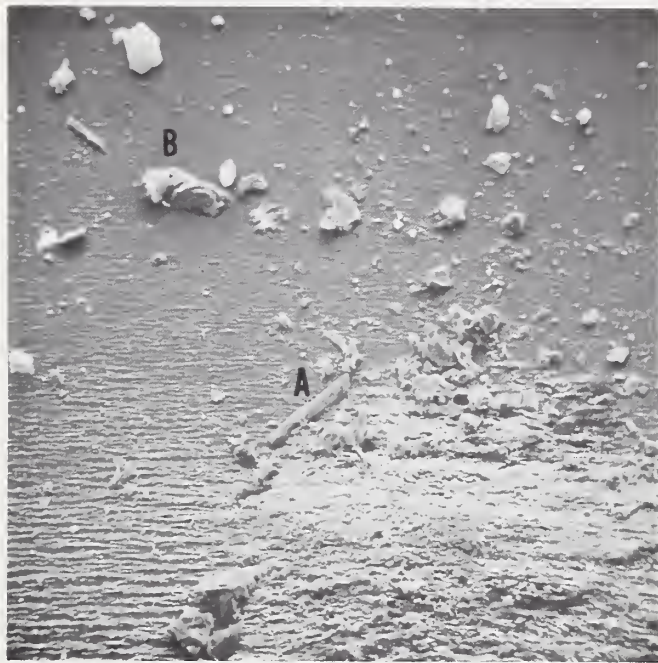
Fig. 1(a). Ferrogram F-2273, oil sample from helicopter gear transmission box. Oil flow is downward. Initial particle deposit region is shown. $M = 100\times$.

The transmission from which this sample was taken had failed after a few hours of operation. There were many foreign or unusual particles detected on this Ferrogram that was produced at Trans-Sonics. The discussion will consider the classes of particles observed, originating at either gear or bearing surfaces. The entry deposit is shown in Fig. 1. The Ferrogram 2273 has been overcoated with a layer of vacuum-evaporated carbon. Some charging is seen at particles within the heavy, initial deposit. Many particles larger than $10\mu\text{m}$ are found near the entrance end of F-2273. Several small spheroidal particles were found (Fig. 1b). One of these is shown in Fig. 2a and contained only iron according to the X-ray emission analysis. A large faceted wear particle of unusual morphology is shown in Fig. 2b. Further down the Ferrogram the usual transverse strings of small wear particles are found, as shown in Fig. 3a. The character of these small ($< 1\mu\text{m}$) rubbing wear particles is seen more clearly in Fig. 3b. A large foreign flake-like particle that is not ferromagnetic has settled there and subsequently the small wear particles were collected in strings that overlay it. The iron peak within the X-ray spectrum from the large flake is actually associated with these small wear particles that have originated from the gear surfaces.

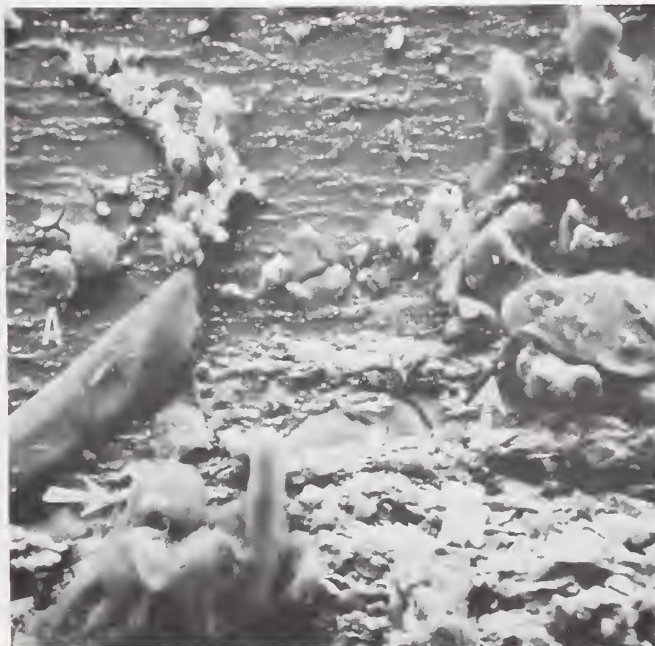
(b). Region near A above. Several spheroidal particles are seen (arrows). $M = 500\times$.

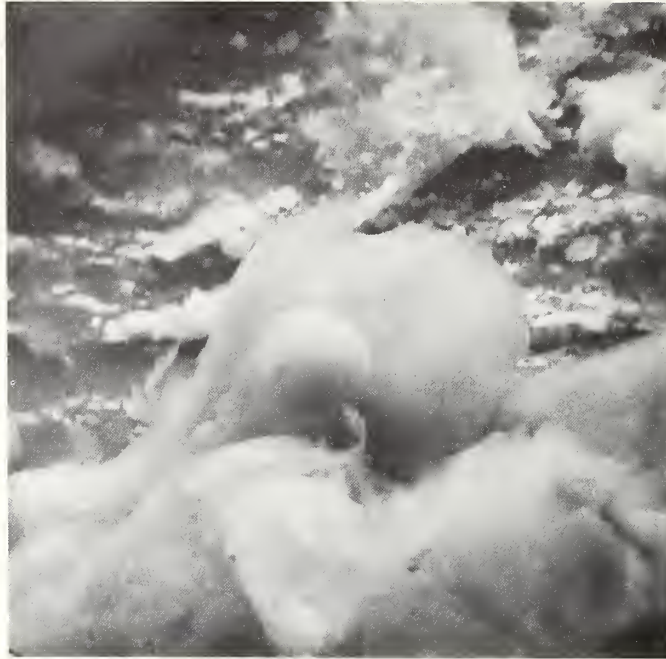
Fig. 2(a). Spheroidal particle shown above. X-ray spectrum indicated only iron in spheroid. $M = 2,000\times$.

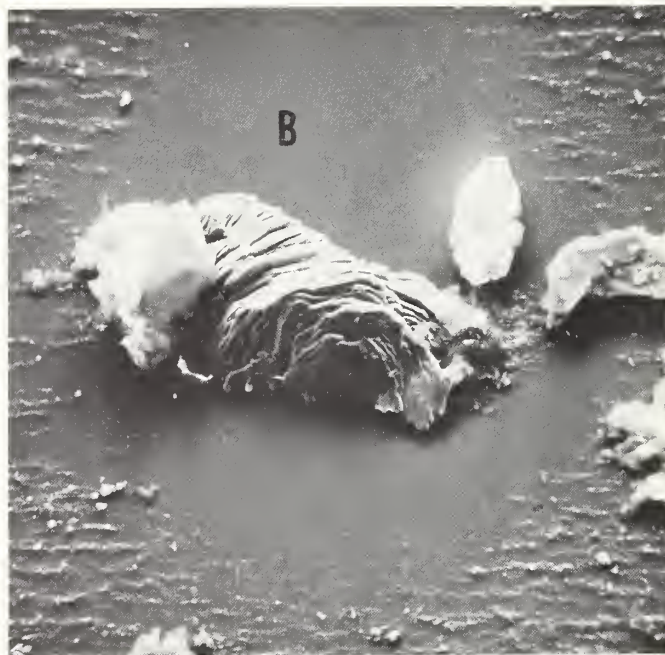
(b). Region B near initial deposit showing large faceted, iron wear particle. $M = 500\times$.

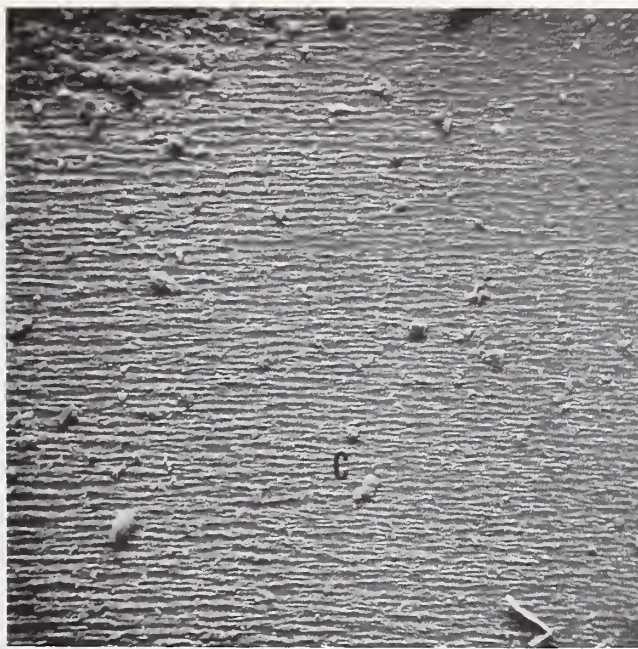
Fig. 3(a). F-2273 region just below initial deposit. Oil flow is downward. Note characteristic transverse strings of small wear particles. $M = 100\times$.

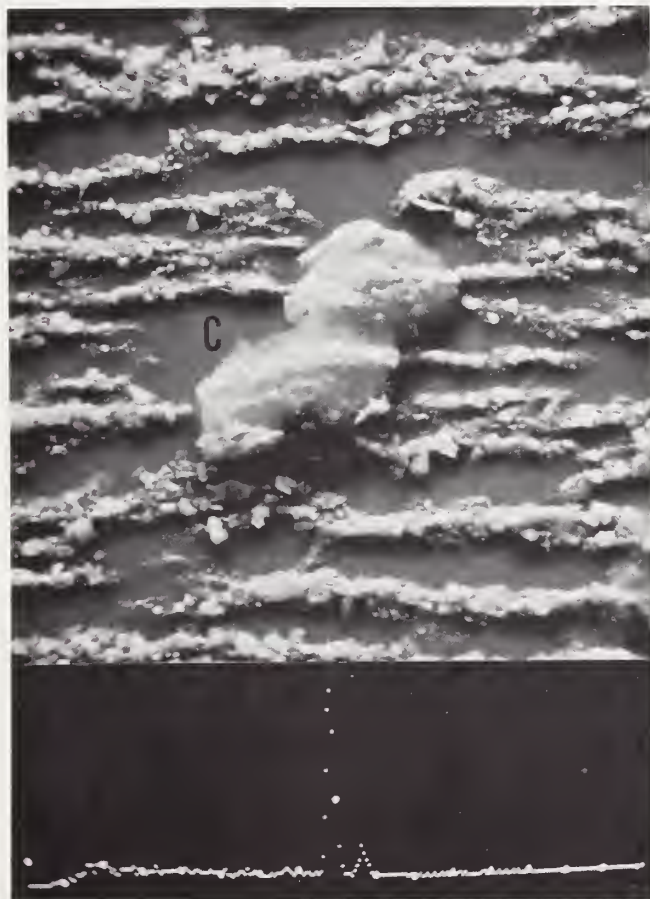
(b). Region C showing large flake underneath small wear particle strings. X-ray spectrum from upper portion of flake is shown. $M = 1,000\times$.

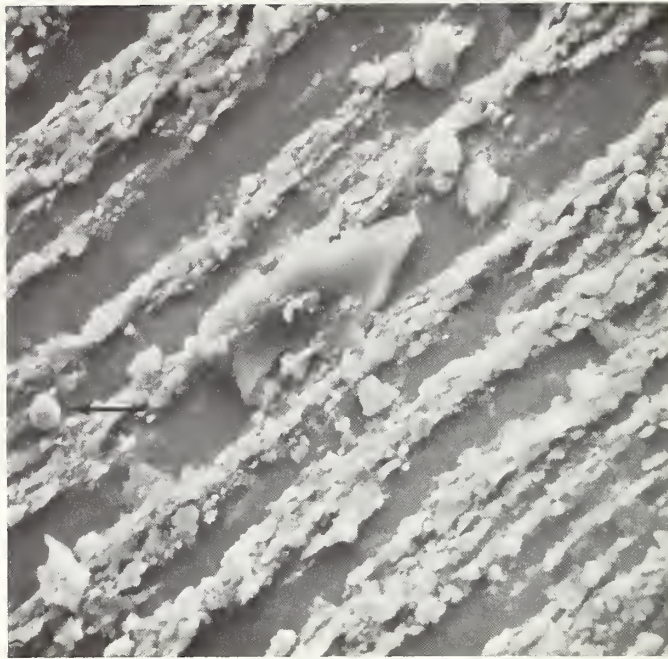
Fig. 4. Region further down from initial deposit in F-2273. Note spheroid at arrow. Particle size in strings varies from $5\mu\text{m}$ to well below $1\mu\text{m}$. Many flake-like particles are found. $M = 1,000\times$.

The wear particle strings further down the Ferrogram are shown in Fig. 4 (rotated from the previous orientation). The variation in particle size within the strings is large. Many flake-like wear particles can be identified. In this field one iron spheroid is seen, as is another large foreign flake-like particle. Recently Cummins *et al.*⁸ described observations on wear debris from a spur gear system. They reported principally small particles of thickness $0.2\mu\text{m}$ or less (note the small particle strings here in Figs. 3 and 4) together with some few spherical particles. The needle-like particles they observed were not found in the present sample. A large, faceted wear particle such as shown in Fig. 2b may originate in a fatigue-cracking process in the manner described by Venkatesh and Krishnamurty in their study⁹ of cracking in gear systems.

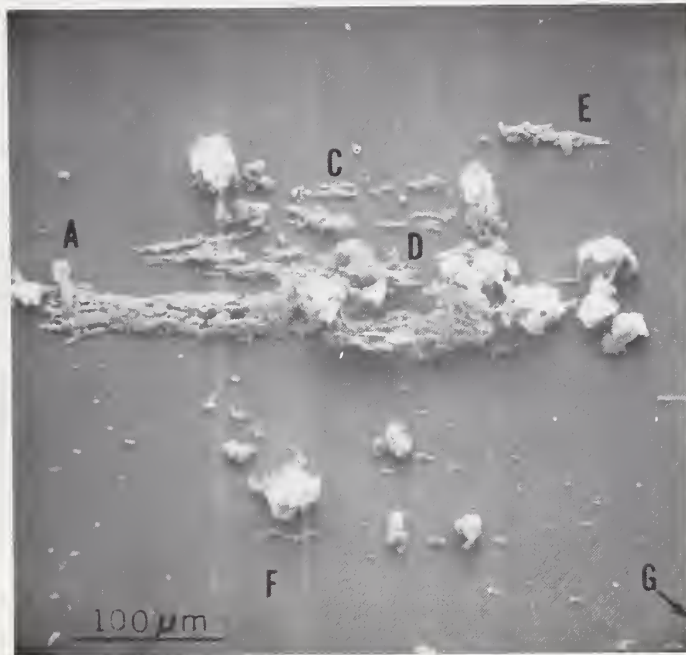
Fig. 5. Ferrogram #2117 from SKF service tank oil, lubricating bearing tests. Carbon-undercoated Ferrogram, scanning electron micrograph, $M = 200X$. Region shown is at entrance end, oil flow downward. Some particles (metal?) are charging in electron beam due to insufficient electrical contact with substrate. Regions labeled are shown in several subsequent photographs for greater detail on particles.

The oil sample was obtained from SKF and originated from a lubricating system used during rolling bearing tests. The Ferrogram (F-2117) was prepared at Trans-Sonics using carbon precoated slides furnished by us. The same oil had been used previously to prepare F-1851 that was examined and will be discussed later. Optical examination of F-2117 at Trans-Sonics indicated the presence of cutting wear particles, spherical particles, and spalls. The entrance end of

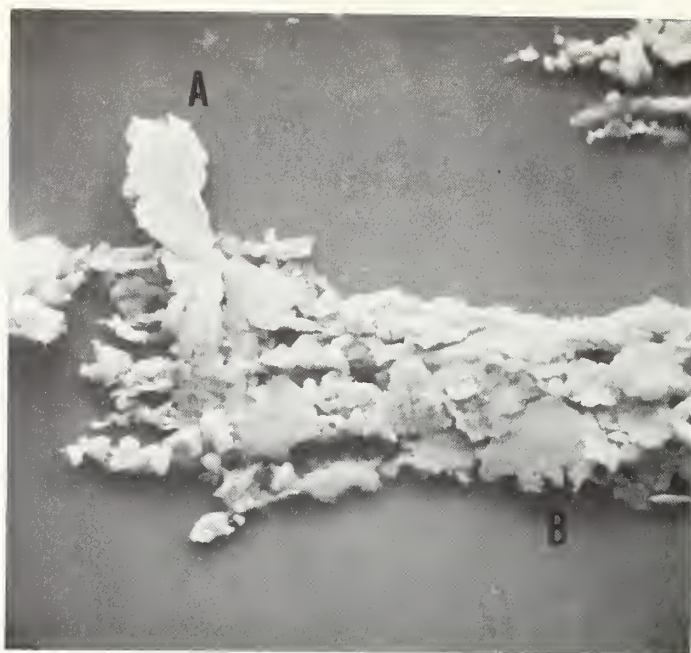
Fig. 6(a). Region A from above. Many flake-like particles are seen in size range 1 to 10 μm . $M = 1,000\times$.

The region A is shown at higher magnification in Fig. 6. Many flake-like particles are seen, the larger ones being about $10\mu\text{m}$ in lateral dimensions and of the order of $0.1\mu\text{m}$ thick. Most of the flakes are bent and corrugated with ragged edges and evident surface features such as lines or bands. Many small particles, less than $1\mu\text{m}$ in size are also seen. The larger flakes presumably fractured or spalled away from the bearing material during contact wear and stressing. They could subsequently have been further deformed if recirculated through the bearing contact regions by the lubricating oil and even fractured again to produce some of the smaller particles. The expected EHD film thickness would be one-tenth or less the size of these particles (order of $10\mu\text{-inch} = 0.3\mu\text{m}$).

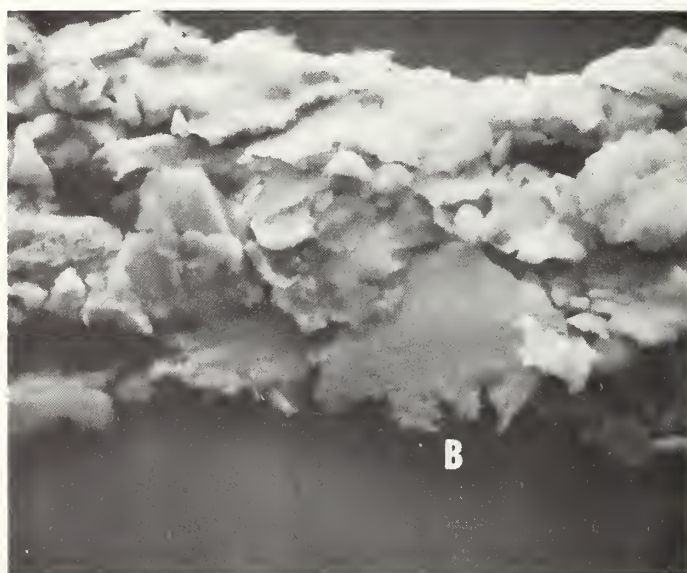
(b). Region near B from above. Surface structures on particles near B appear as slip or deformation lines. Flake above B and flake at left contain only iron. $M = 2,000\times$.

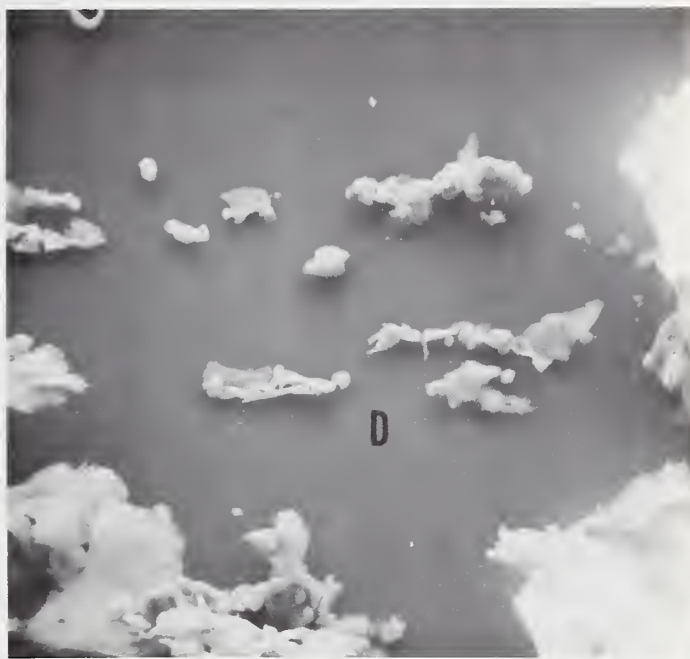
Fig.7(a). Region D from above. Several small particles strings are shown together with some isolated particles. $M = 1,000X$.

Another region from Fig. 5 is shown in Fig. 7. One observes substantial differences in contrast between the particles. The particles showing lower secondary electron emission (grey images) are probably more heavily oxidized and hence contain less iron. Some particles show a porous surface structure that is also suggestive of oxide material. It is recalled that the particles have not been overcoated prior to examination, hence the existing surface structures are preserved. Flake-like particles are observed together with several rod-like particles.

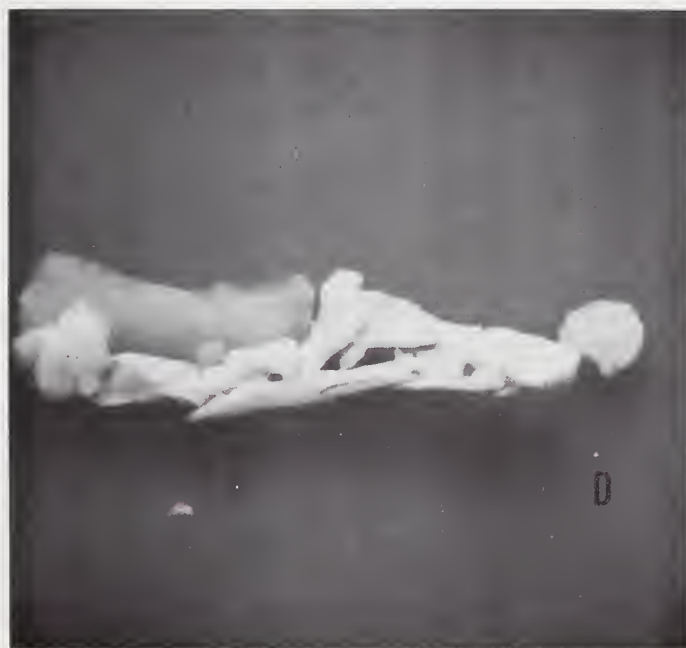
(b). One string from above area containing particles showing different emissive image contrast as previously reported. $M = 4,000X$.

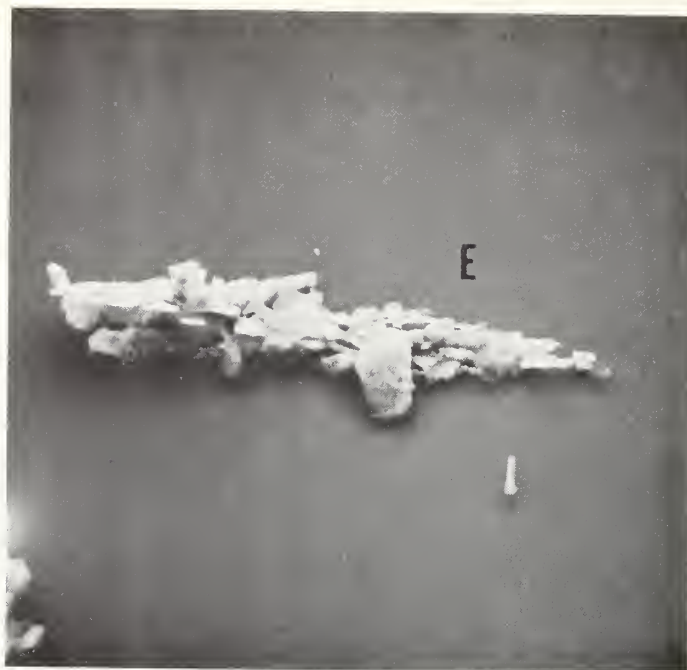
Fig. 8(a). Particle string from Region E in above. Many flake-like particles are seen with resolvable surface structures. $M = 1,000X$.

The region E from Fig. 5 is shown in greater detail in Fig. 8. One flake-like particle in this string has considerable surface structure that includes several cracks and smaller, attached particles. A spheroidal particle ($2.4\mu\text{m}$ diameter) is also seen. Its size is sufficiently large to contain nearly all the X-ray emitting volume permitting meaningful X-ray emission analysis. However, fluorescence effects associated with neighboring particles in such a collection could be substantial and require correction. Analysis of this spheroid showed only an iron peak in the X-ray emission spectra as shown. The large flake-like particle contains a significant amount of iron and zinc.

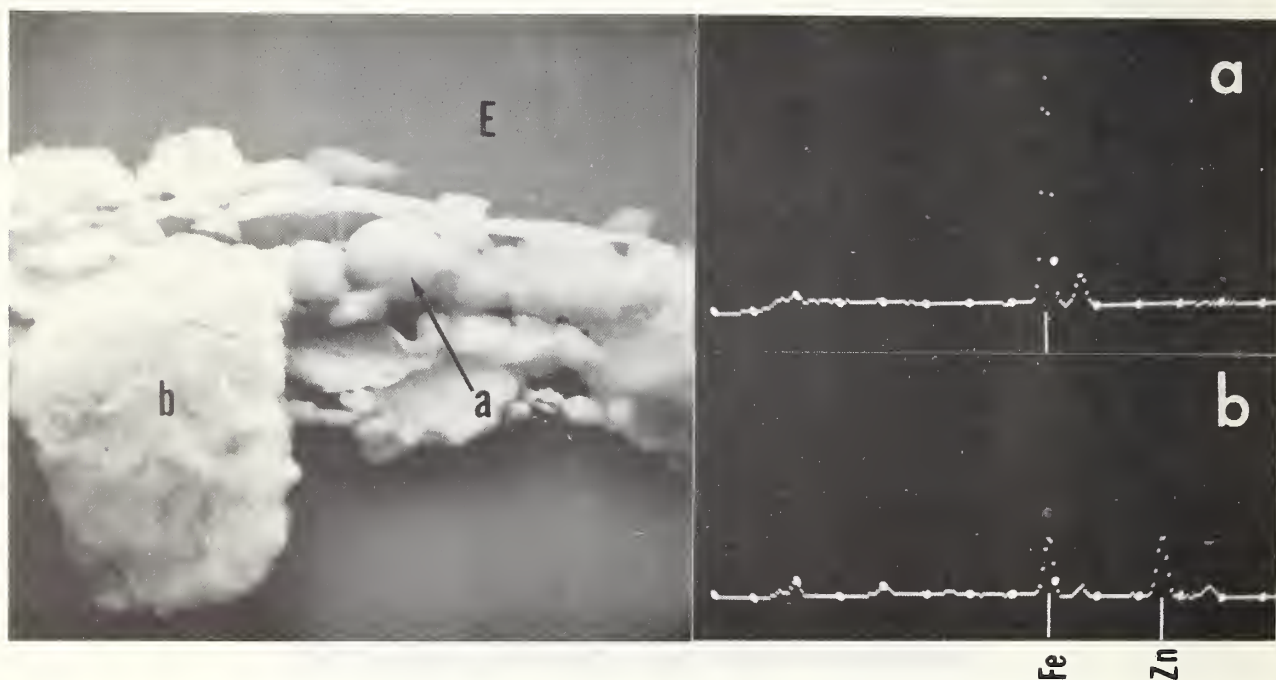
(b). Details in above particle string. Note surface features on large flake at left. Spheroidal particle (a) of $2.4 \mu\text{m}$ diameter is shown. X-ray analysis indicates (a) spheroid contains only iron and (b) flake has reduced iron and significant zinc content. $M = 5,000X$.

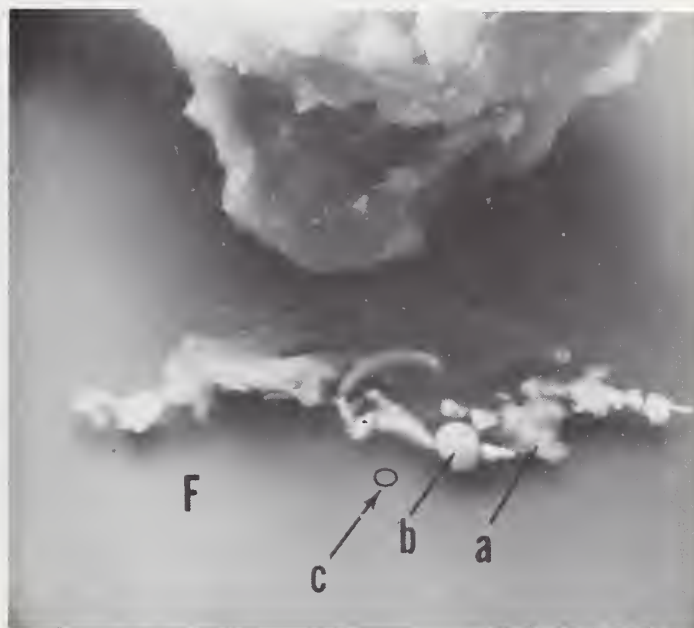
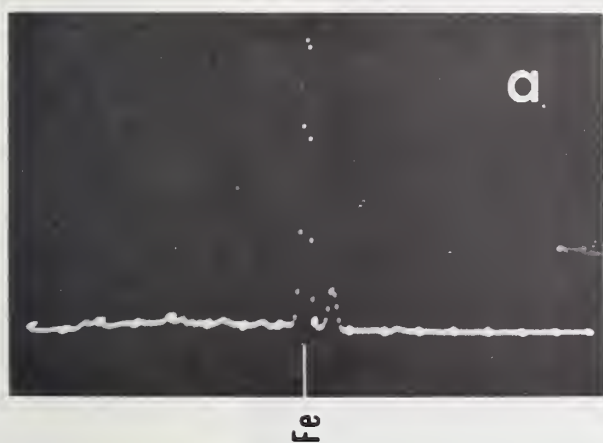
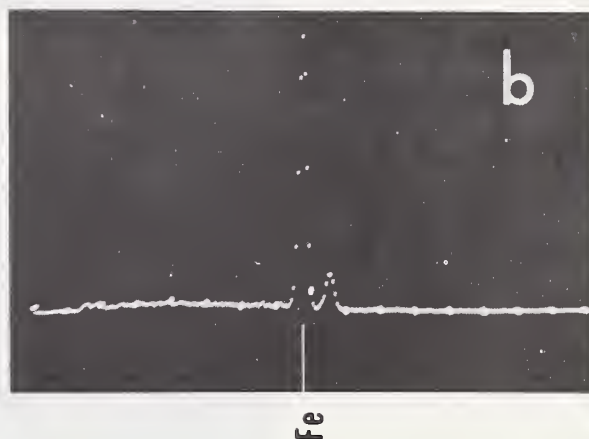
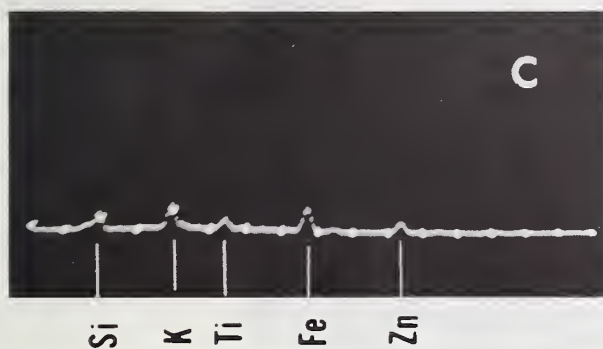
Fig. 9. Region F from above. String contains several particles, one of spheroidal shape (b) of $2.5\ \mu\text{m}$ diameter. X-ray emission spectra are shown for particles (a) and (b) and background region (c). Both particles are iron. $M = 2,000\times$.

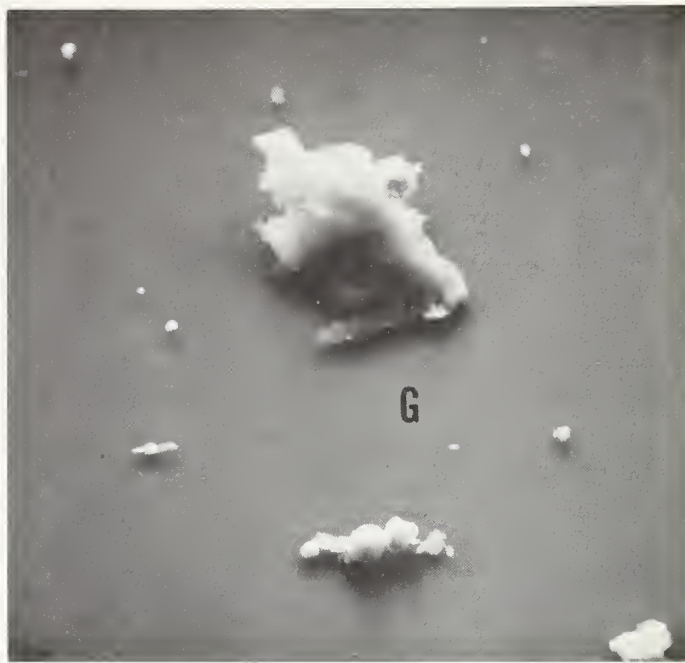
Fig.10(a). Particle string from Region G in Fig. 5. (slightly outside area shown). Spheroidal particle diameter is $4.5\ \mu\text{m}$. Large blob gives typical background X-ray spectrum. $M = 1,000\times$.

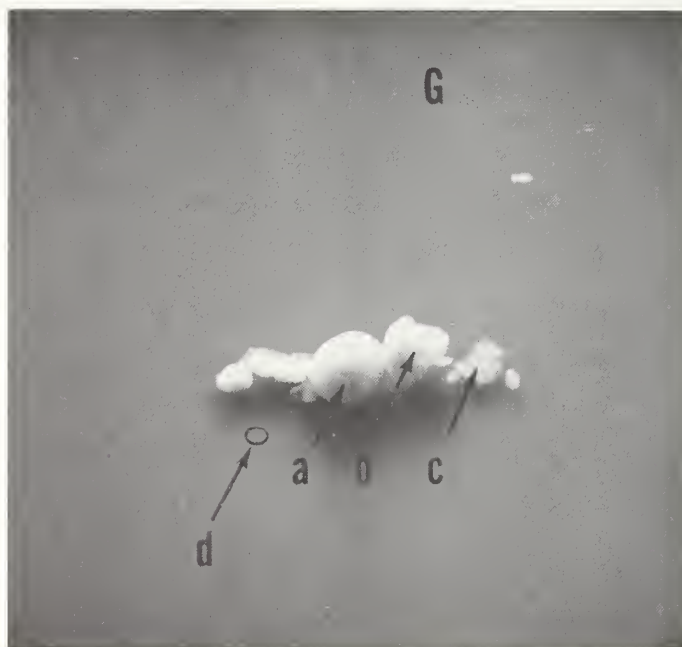
(b). Details of above string. Note contrast differences between particles. X-ray emission spectra were obtained from labeled particles. Spheroidal particle is iron. Particle (c) contains oil residue. $M = 2,000\times$.

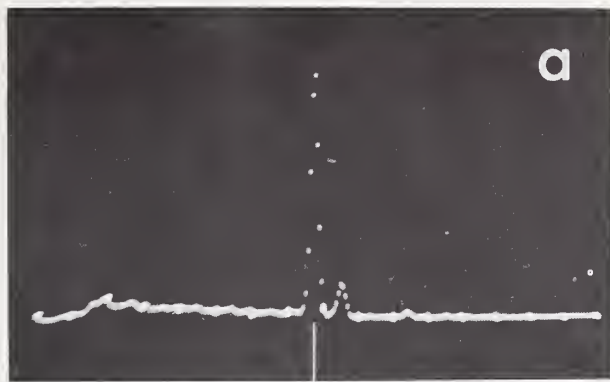
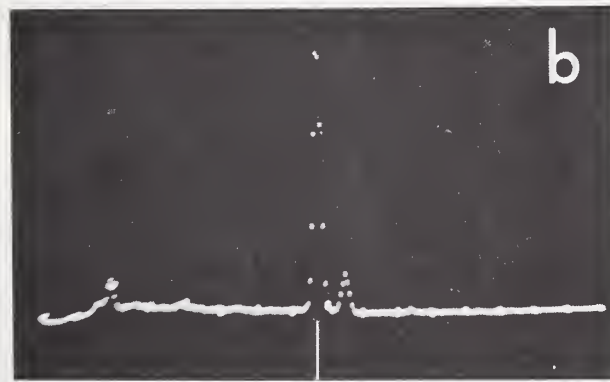
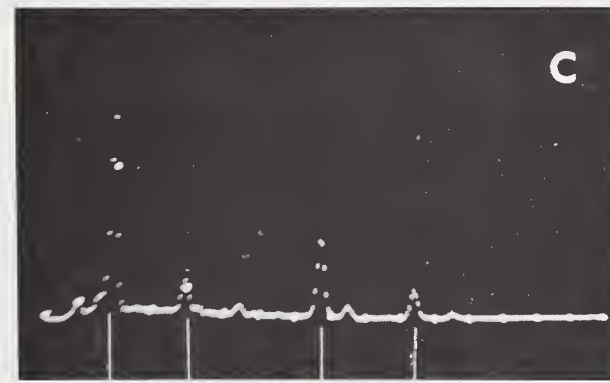
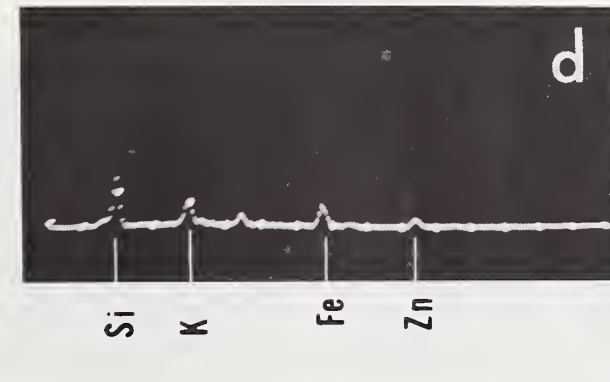
10(c). X-ray spectra from particles (a), (b), (c), and background (d).

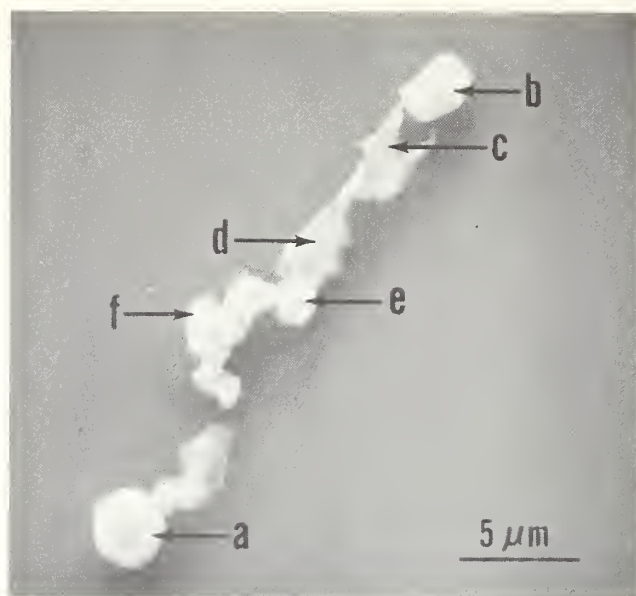
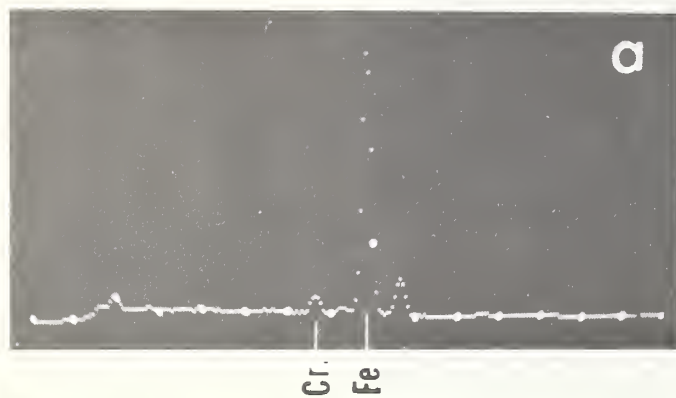
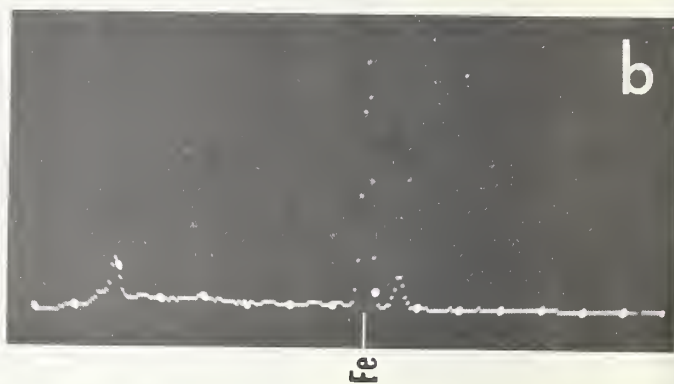
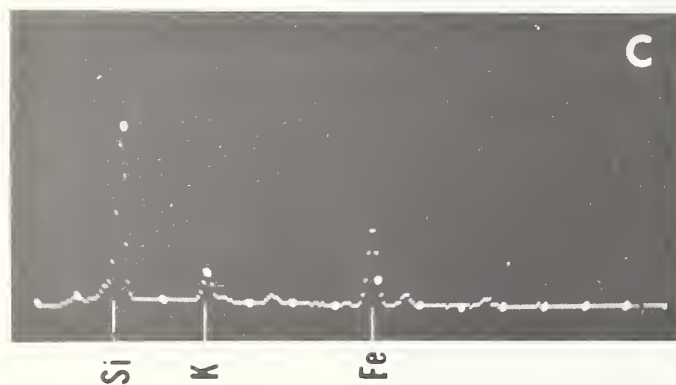
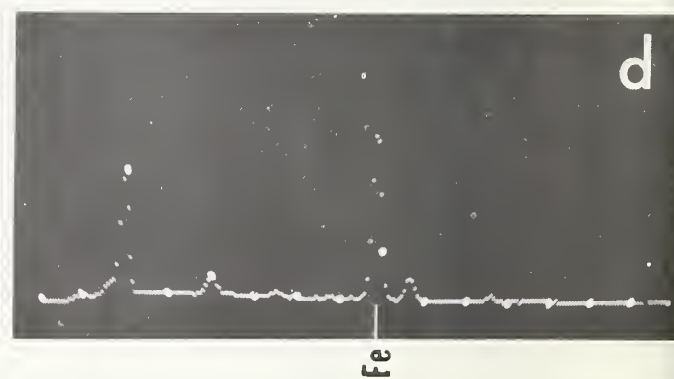
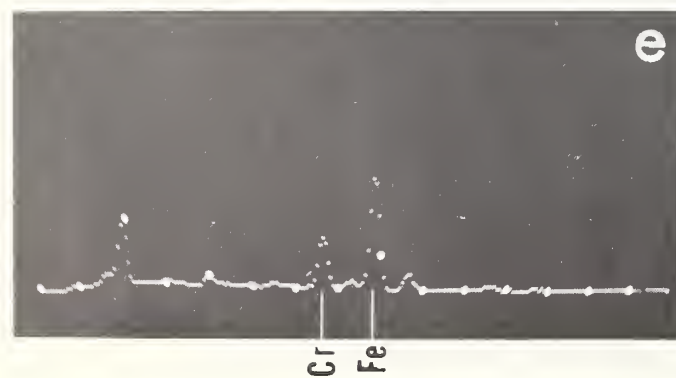
Fig. 11. Particle string from F-2117 with X-ray spectra as indicated.

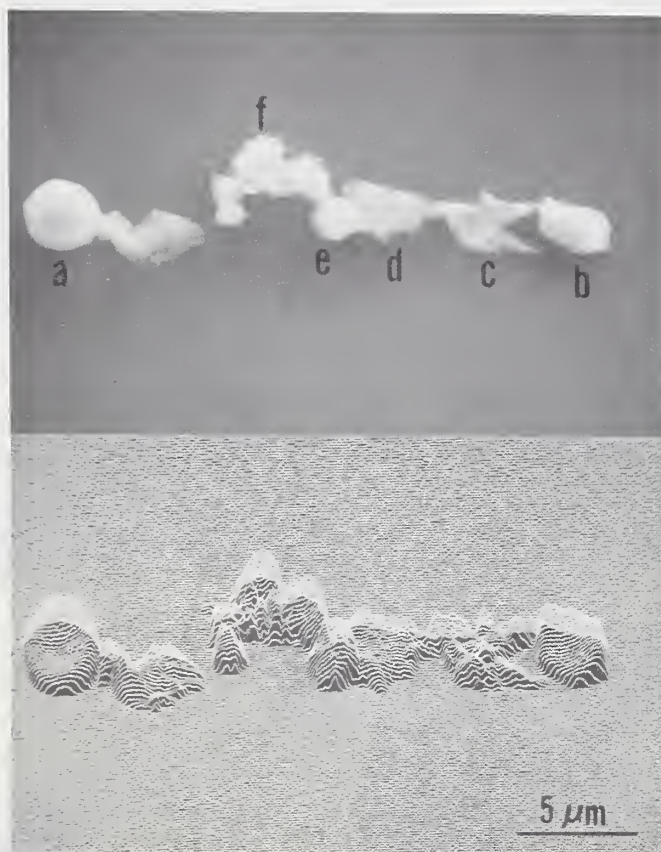
Particle			Peak Heights
Shape	Size (μm)	Ident.	K_{α} - 1,000 cts Fe : Other
a - spheroid	3	alloy steel	1.1 : 0.1Cr
b - lump	3	iron	1.1
c - flake	3	iron oxide	0.3 : 0.7Si
d - lump	3	iron oxide	0.7 : 0.5Si
e - lump	2	alloy steel oxide	0.5 : 0.2Cr : 0.2Si
f - lump	1.5	iron	0.8

Fig. 12. Particle string above showing intensity variations in Y-modulation. Analysis results are shown.

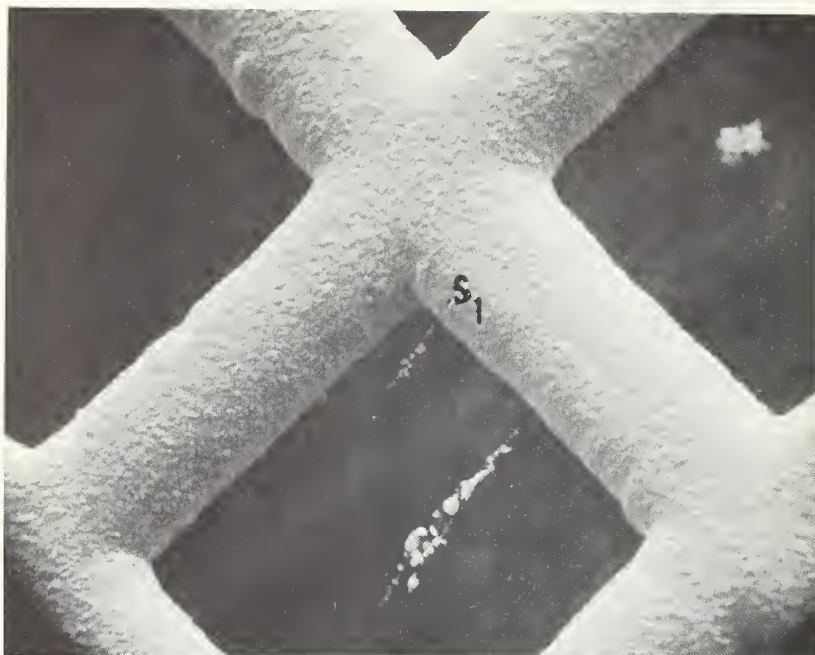
Fig. 13(a).
F-1851. One support grid opening containing two particle strings on carbon film in SEM. $M = 600\times$.

A second study was conducted on wear particles from the SKF test of 52100 steel ball bearings. Rather than carbon-coat the Ferrogram-1851, we removed the particle strings from the glass substrate by extraction replica techniques. This would permit high resolution imaging in a transmission electron microscope (TEM) and transmission electron diffraction (TED) examination, particularly of the smaller particles. A softened polymer film was pressed onto the Ferrogram, allowed to harden, stripped off, and overcoated with carbon, and then the polymer film was dissolved in solvent. The resulting carbon film contained the partially embedded particle strings and was supported on a conventional copper grid that could be loaded directly into the TEM specimen holder. Figure 13a shows two strings located in one grid opening. This same area is shown in the optical microscope photograph in Fig. 13b, indicating the versatility in this preparation and mounting technique.

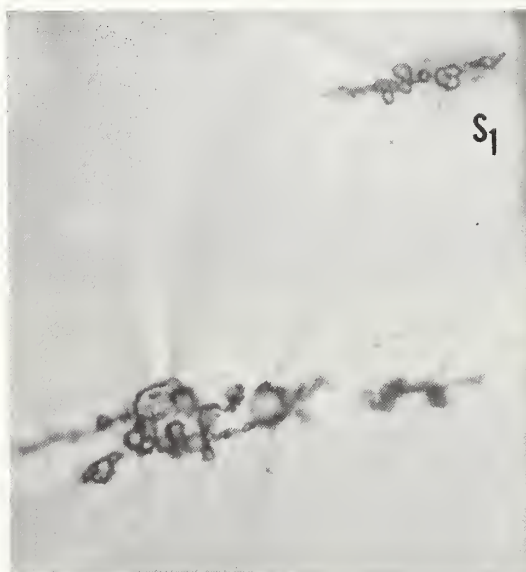
(b). String S_1 on carbon replica in the optical microscope. $M = 1,000\times$.

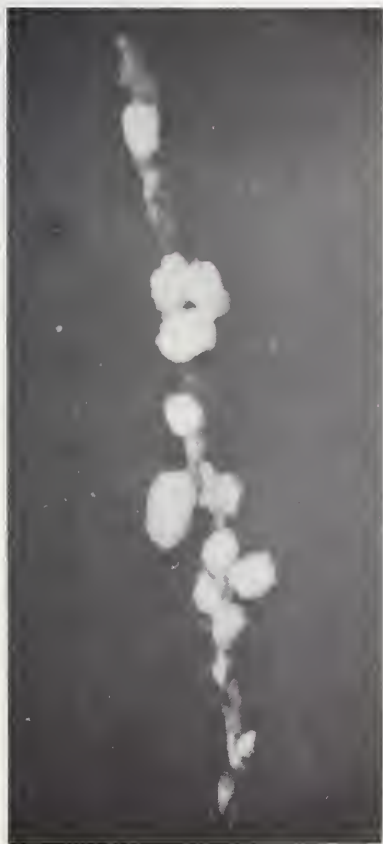
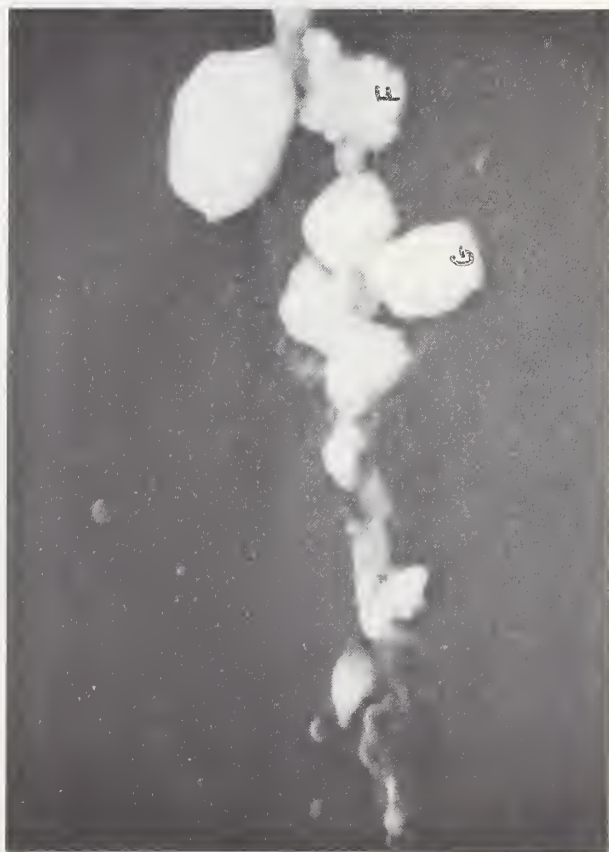
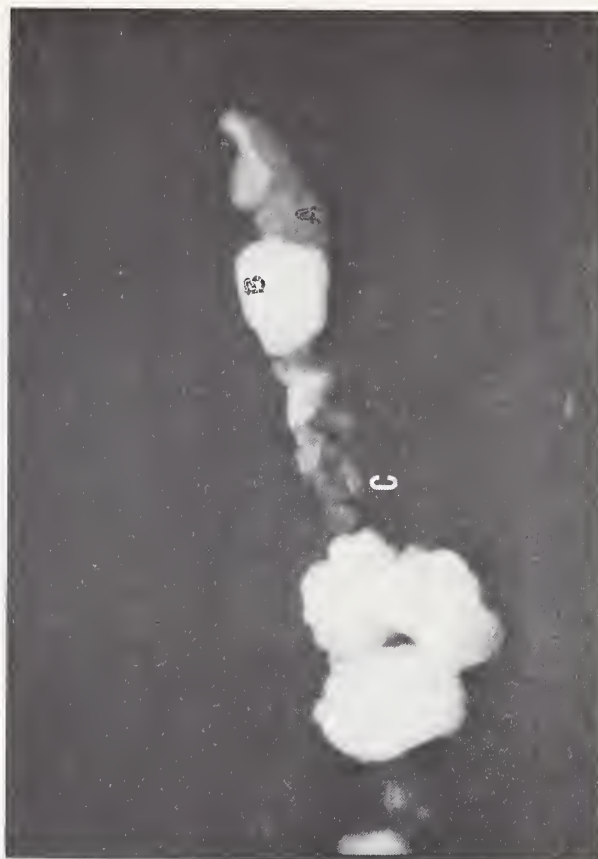
Fig. 14. String S₁ in SEM. Note contrast differences among particles. M = 5,500x. Details below at M = 11,000x.

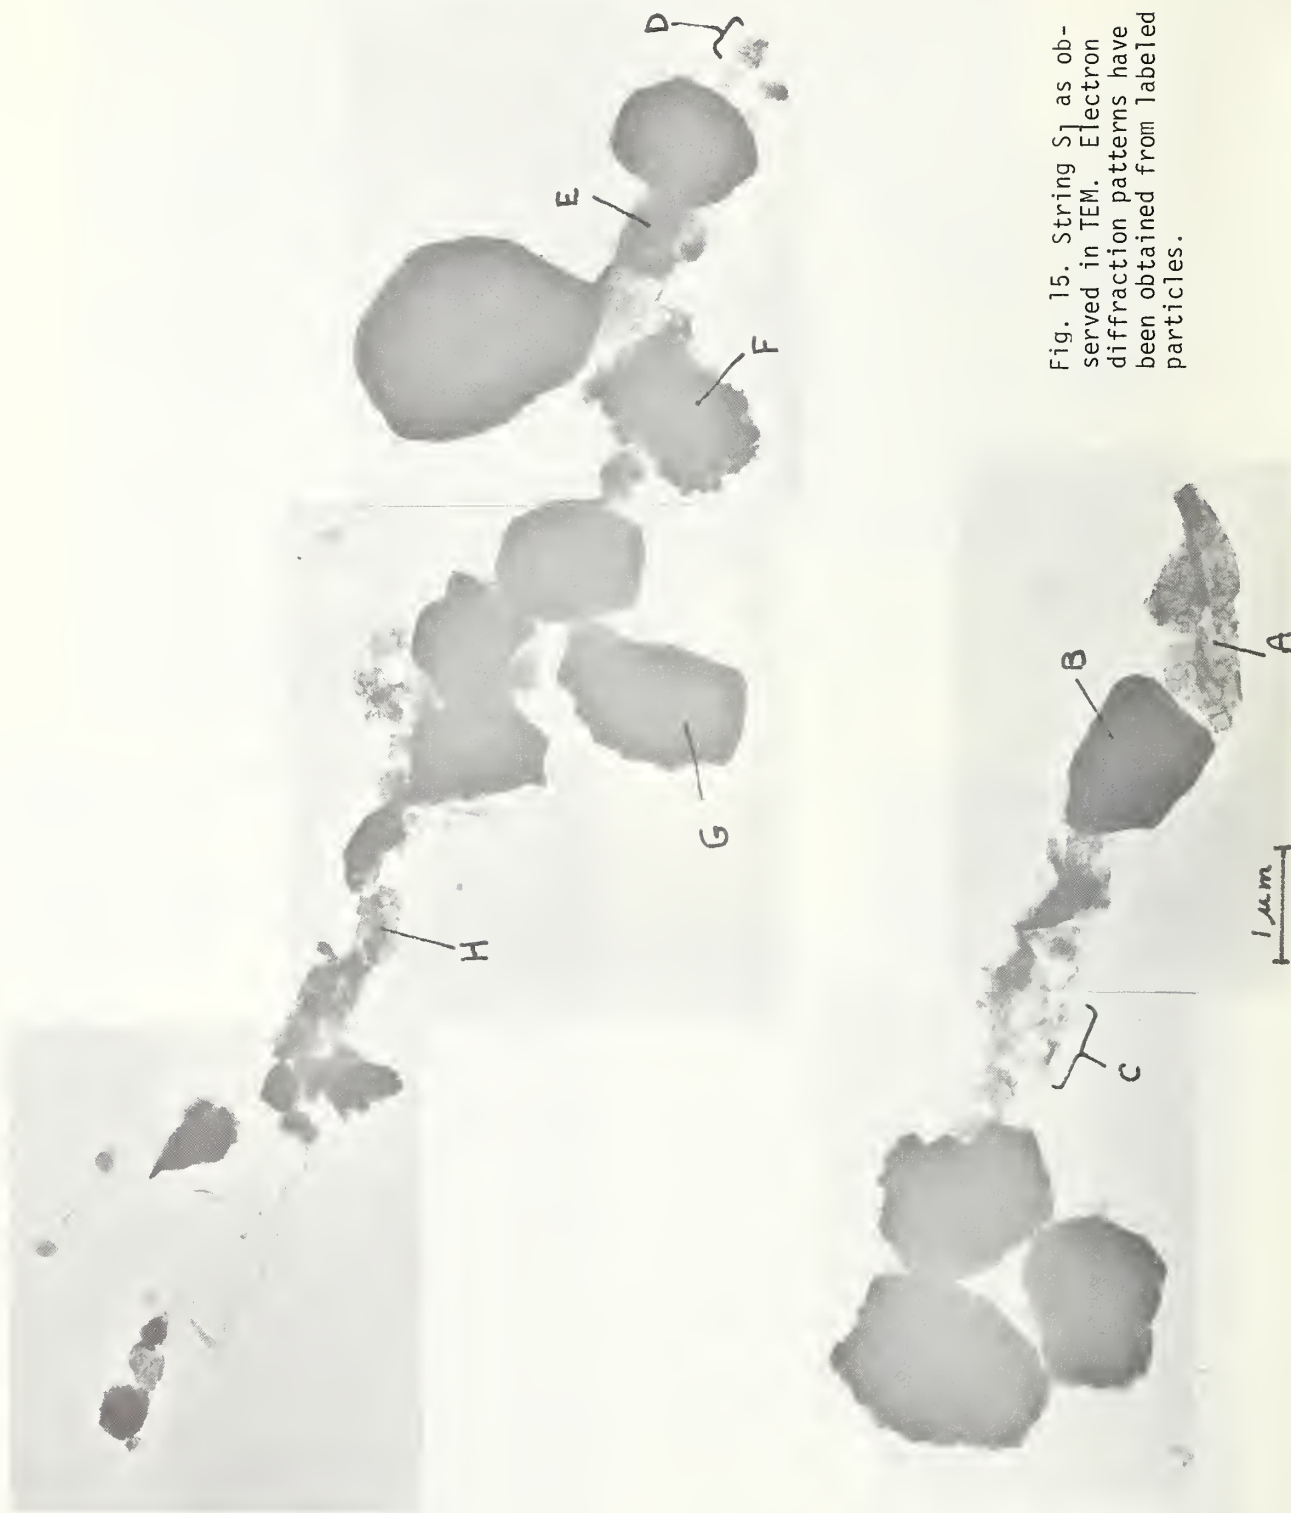
Fig. 15. String S1 as observed in TEM. Electron diffraction patterns have been obtained from labeled particles.

In summary, the string S_1 contains a number of different particle types. Thinner particles may be solid iron, composed of many crystallites (A), they may be a loose collection of much smaller iron oxide particles (C), or they may be relatively thick iron particles with an oxide coating (B). No carbide particles were found in this string. A more detailed electron diffraction pattern is shown in Fig. 17 with the principal lines for α -Fe and Fe_3O_4 identified. The Fe_2O_3 pattern contains two additional lines that serve to distinguish it. As long as sufficient diffraction intensity is obtained, solutions of patterns from particles are straightforward.

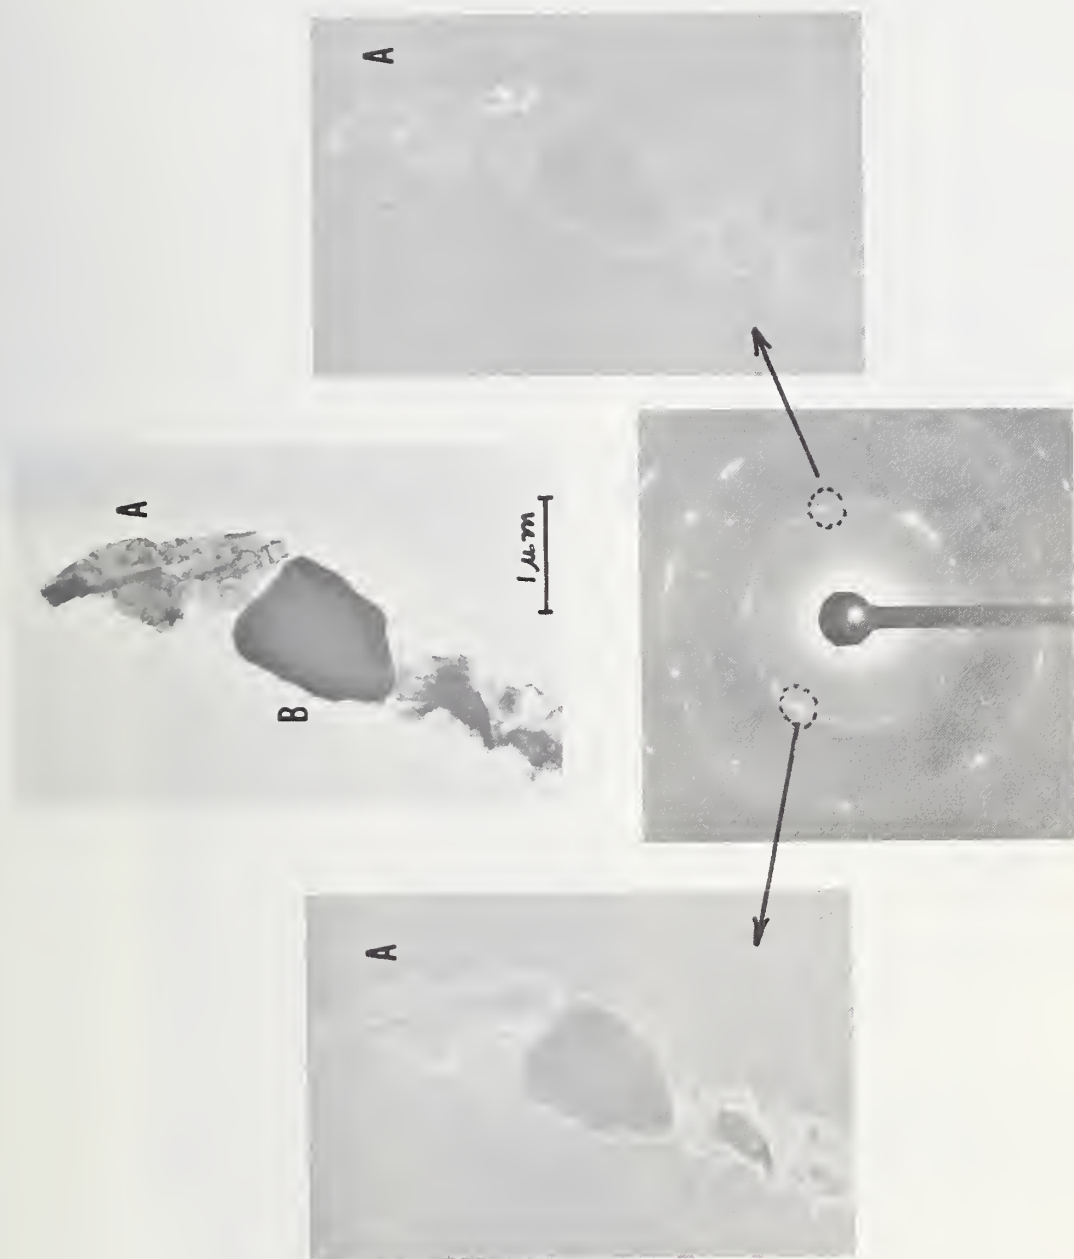
Fig. 16. Particles in string S₁ imaged in TEM bright field and two dark field reflections (iron and iron oxide). Note oxide covering at edge of opaque iron particle.

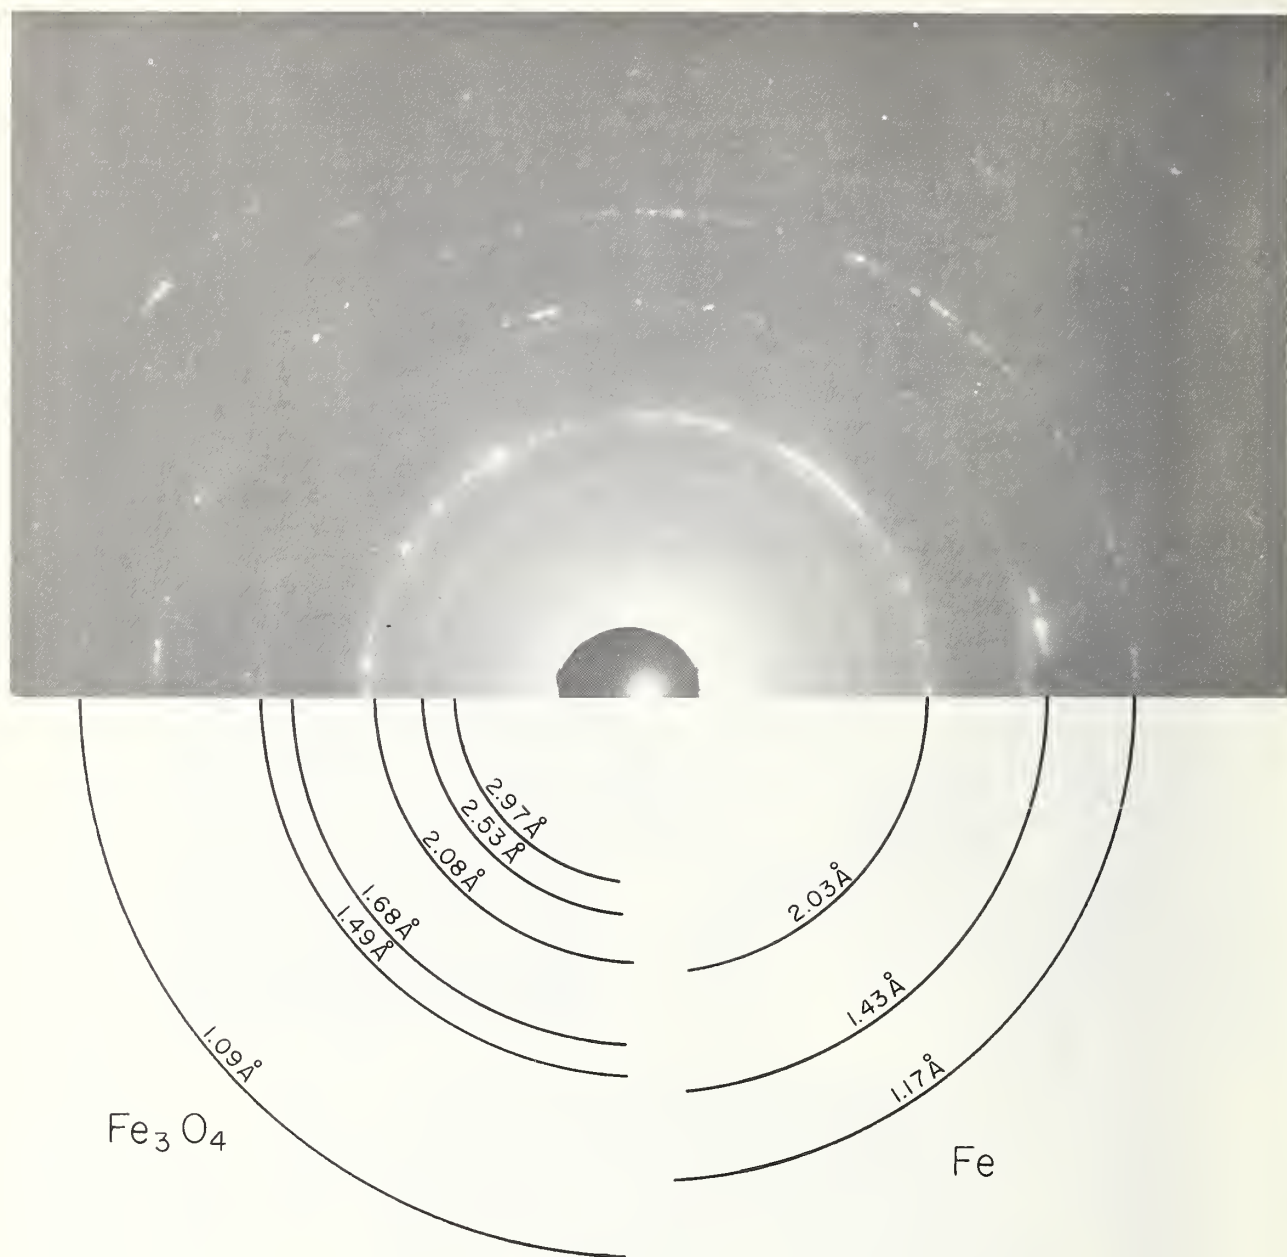
Fig. 17. Electron diffraction pattern from an area of partially oxidized iron particles in one string. F-1851.
